E31 Battery Replacement Procedure

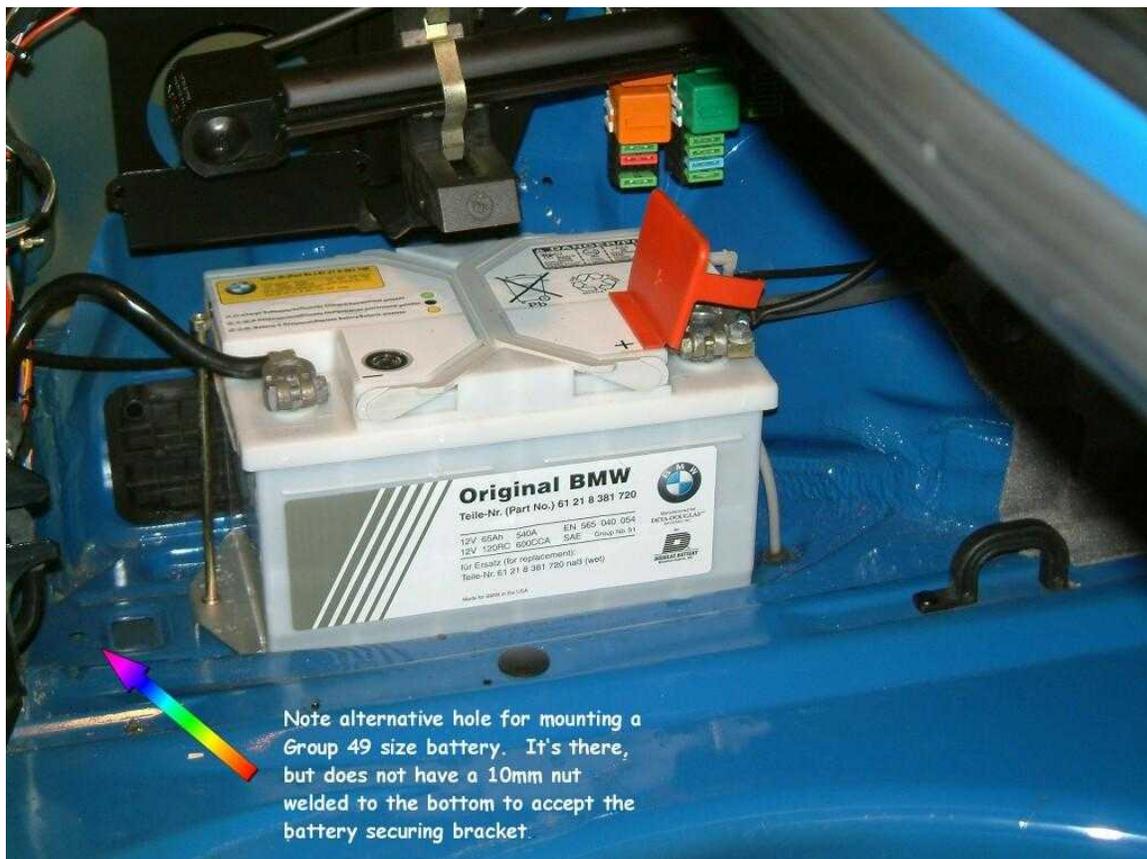
The batteries are accessible on each side of the trunk. In this first picture, you see the driver side battery before removal. Note that the battery tray is welded in at the factory, and that at least on my car, there is only one attaching point for the battery mounting bracket - that has a nut welded to the bottom of the tray. Clearly, the factory intended use of the smaller Group 48 sized battery. But as indicated in the picture, the battery tray does have a mounting hole available to accommodate mounting a Group 49 size battery; it just doesn't have a mounting nut welded in.

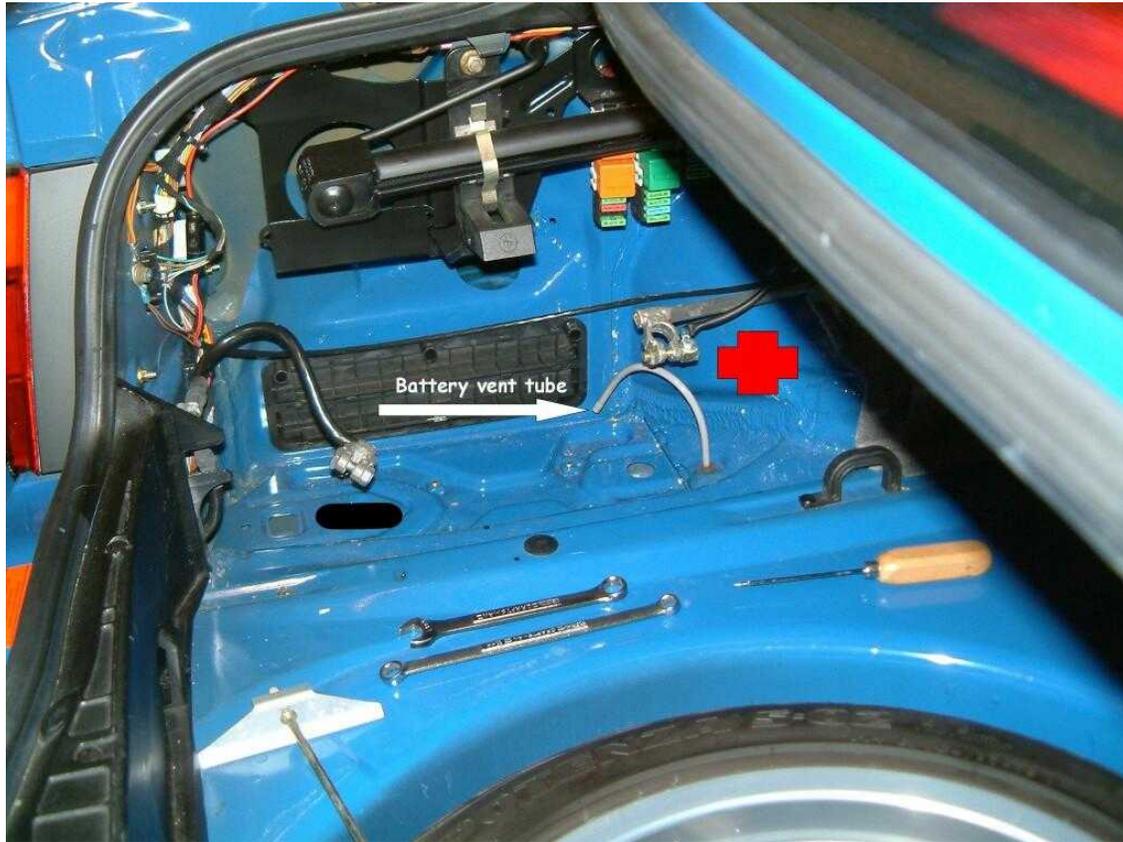
The next image shows the driver side battery tray area with the battery removed. The vent tube is clearly visible.

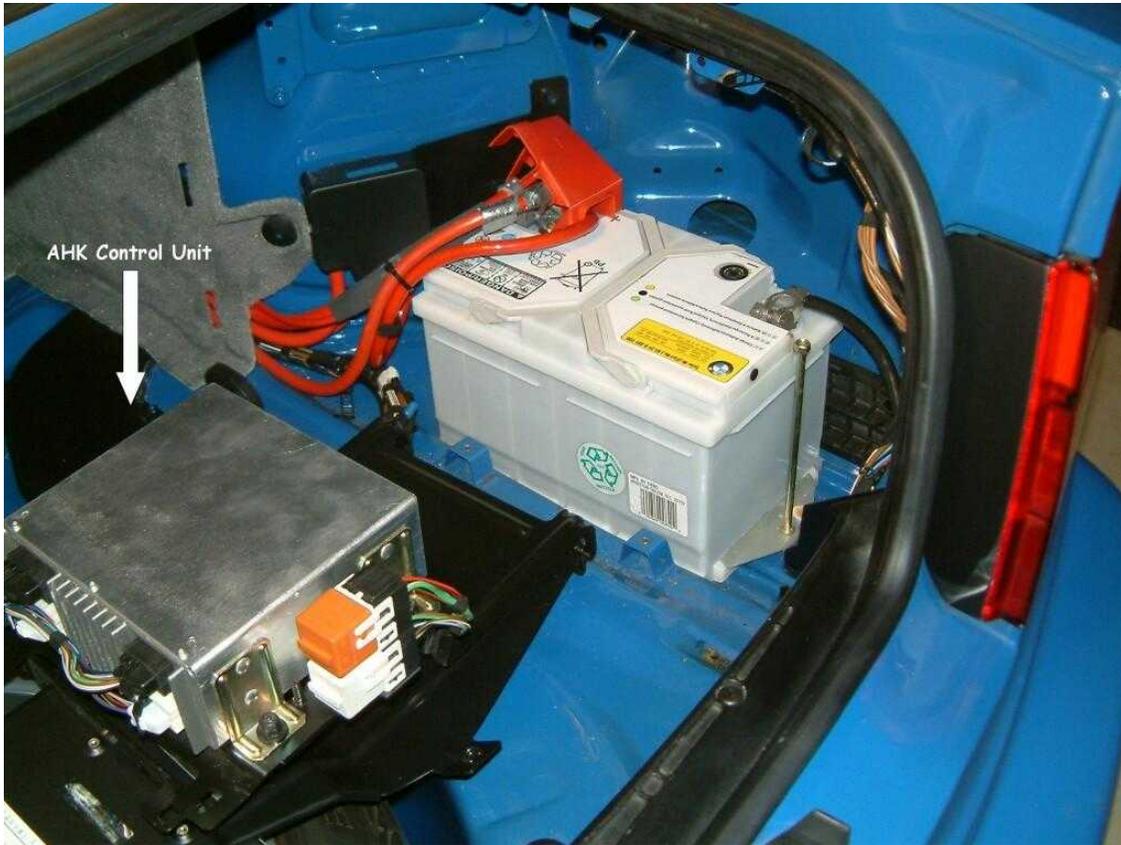
Next, you must remove the mounting bracket. It is secured by four 10mm nuts, two at the top, and two at the bottom. Once the nuts are removed, you can lay the bracket down flat in the trunk. The Euro CSI has the AHK control unit mounted on the back side of the CD mounting bracket, and it is visible in the following photo:

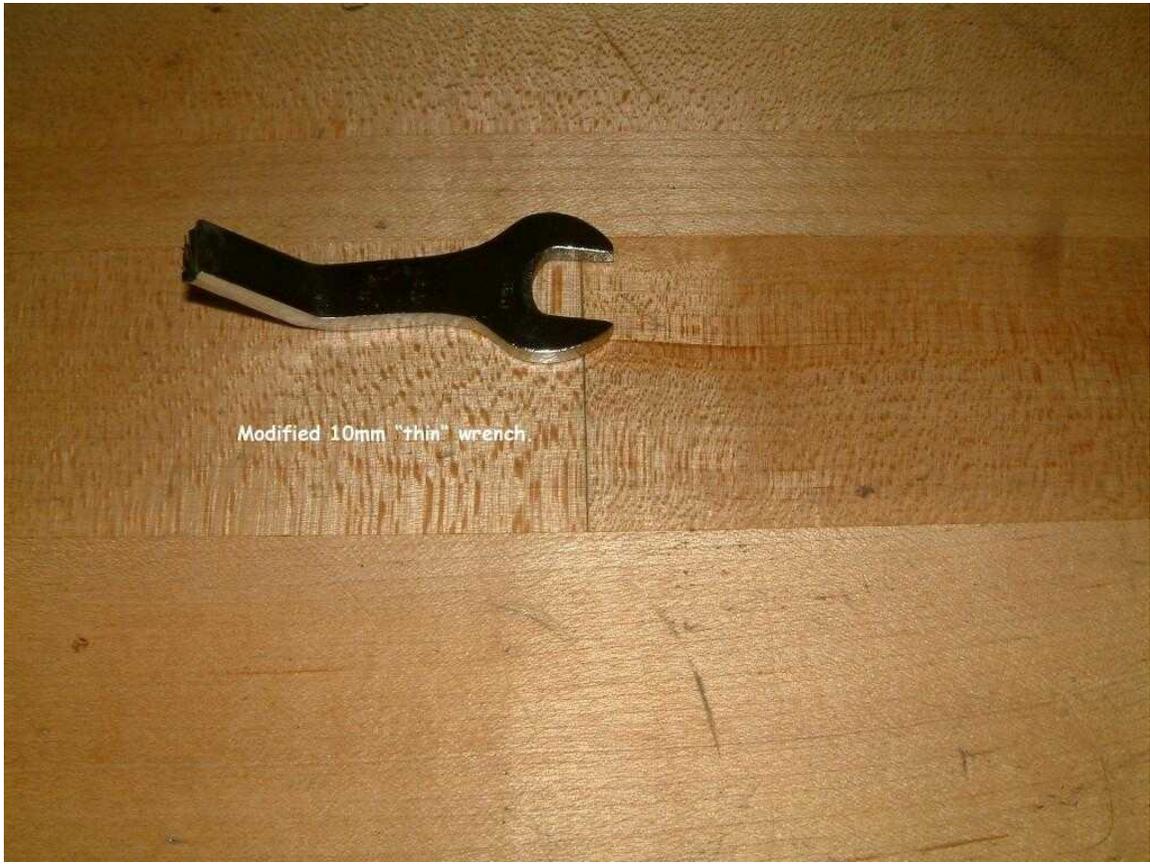
With the bracket removed and out of the way, the remaining battery can then be removed. At this point, all power has been disconnected from the car which will cause all stored fault codes to be erased from memory. The problem now facing me was how to mount the larger batteries using the factory mounting brackets. As noted above, this was a problem because the battery trays do not have a 10mm nut welded to the bottom side to accept the mounting post. How can the post be secured? After stumbling around for awhile, and even considering taking the big Mega-Tron Pluses back for the normal sized ones, the solution came to me and is pictured below. A thin 10mm wrench had to be modified to slide under the bracket to hold the nut in place while the bracket mounting post was secured. The modified wrench:

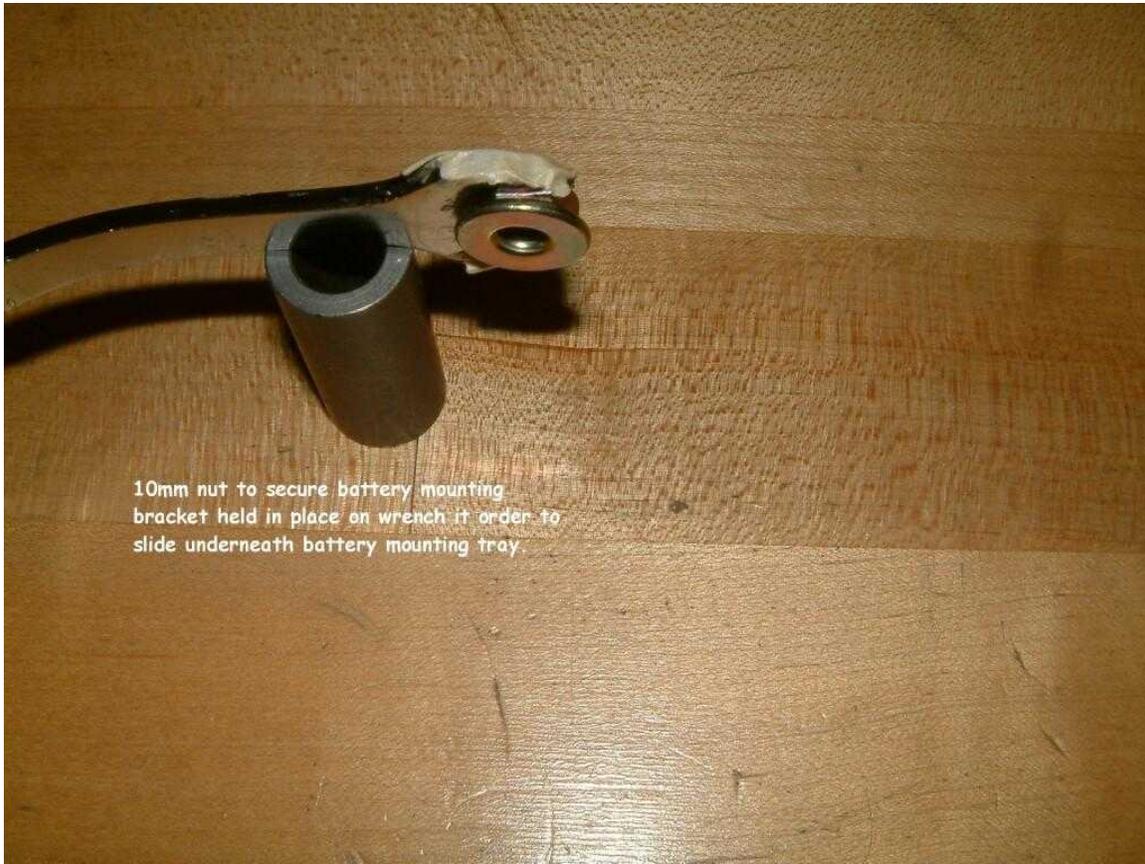
Actually holding the 10mm nut in place with my "special" tool also required some thought. I finally realized the nut could be held to the wrench by using some masking tape on the bottom of the nut that also wrapped onto the wrench.

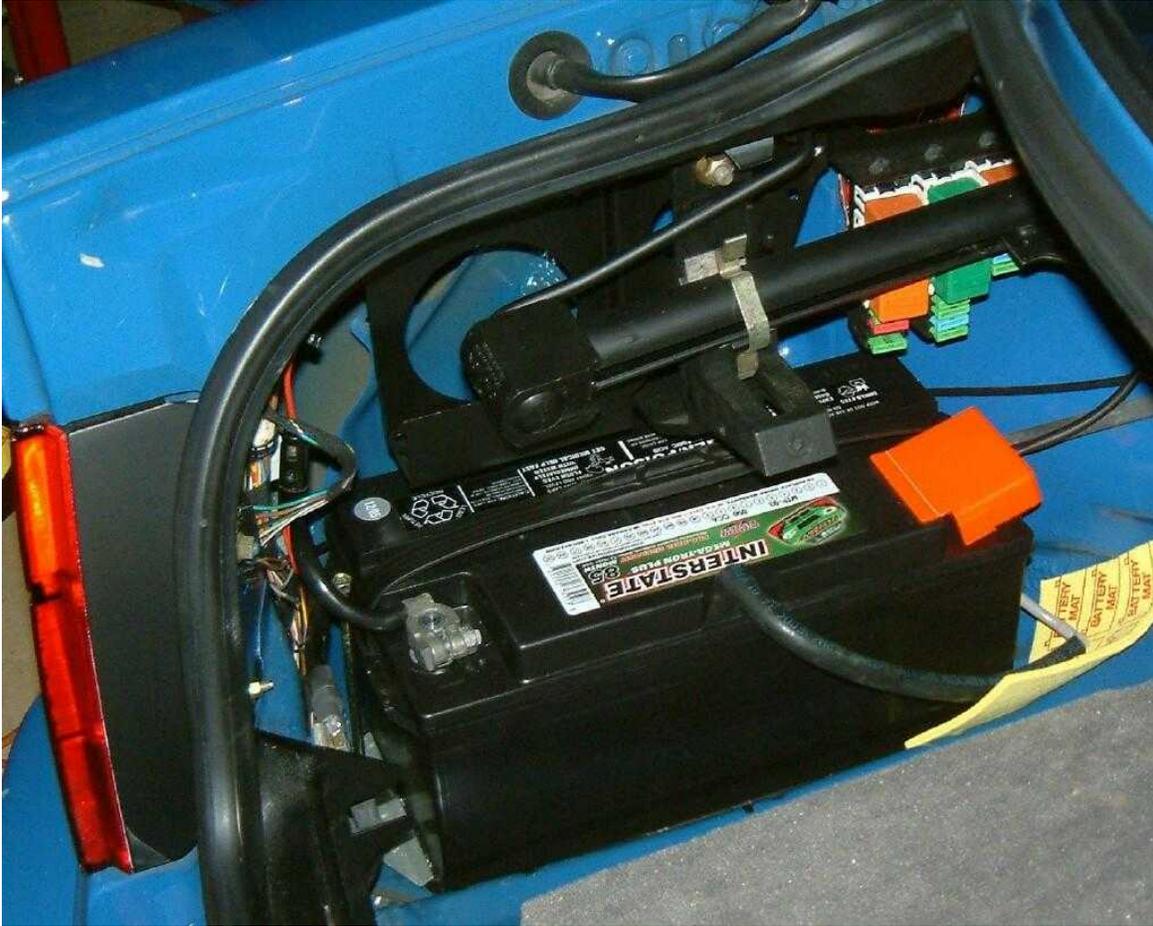
With the mounting bracket problem solved, installing the batteries was easy. Due to the design of the larger Group 49 batteries, it was necessary to extend the vent tube from the battery and connect it to the existing vent tube. The batteries were snugged down, the cables reattached, and the installed Group 49 battery appears as follows:
