Seat-Back release handle replacement.

By: Faisal Ahmed and Gerry and Mitchell Speechley.

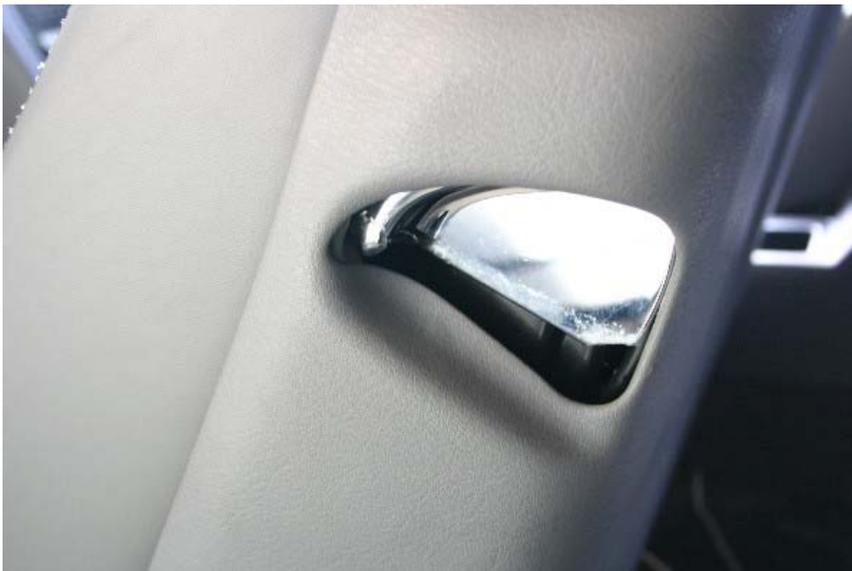
1. Here is a view of the broken seat catch on the passenger side seat.

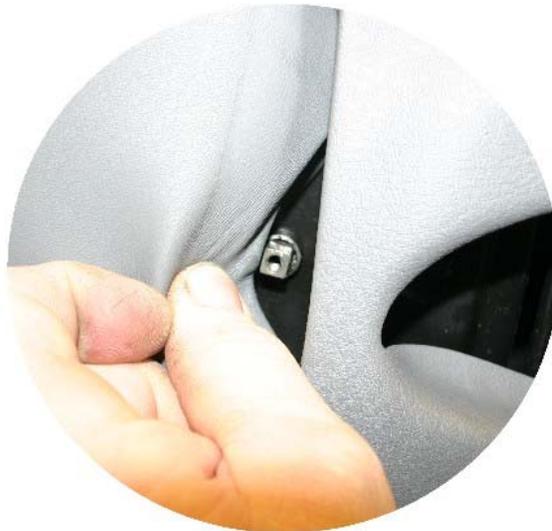
9. Here the actuating arm can clearly be seen.

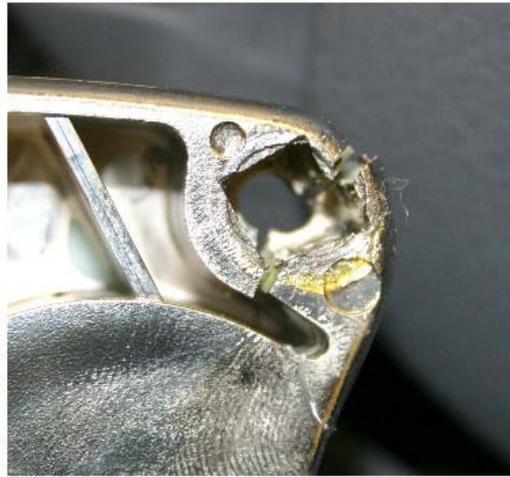
10. This is where the original levers break.

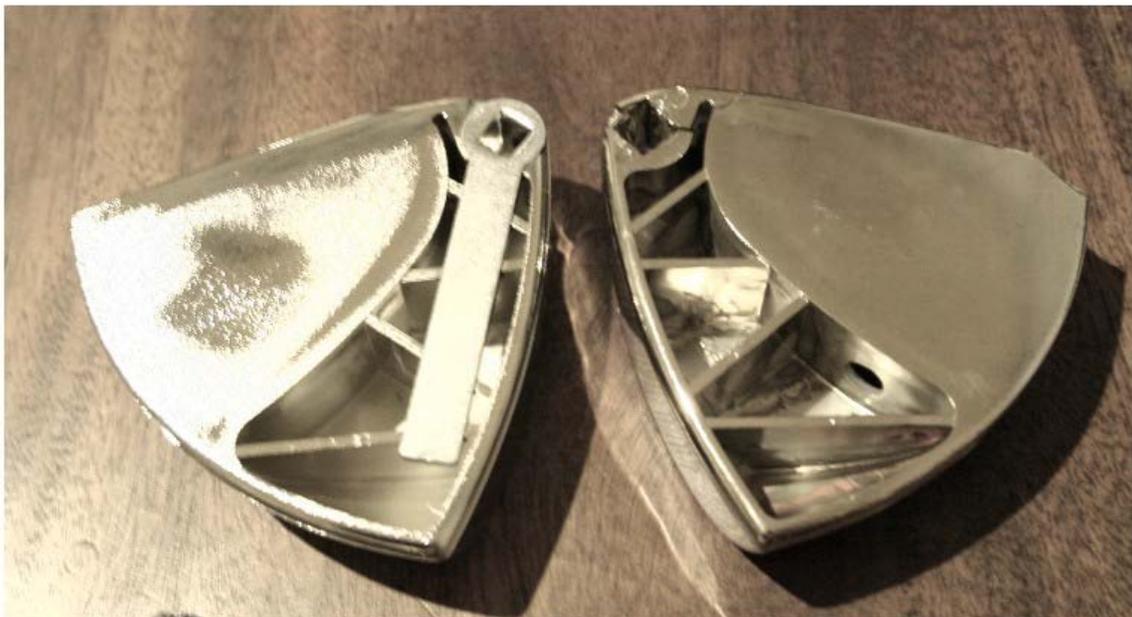
11. Here is a comparison between the new metal reinforced lever and the old type.

12. Slide the new lever onto the catch and secure it with the #25 Torx screw.
