# CAMBER PLATE INSTALLATION GUIDE

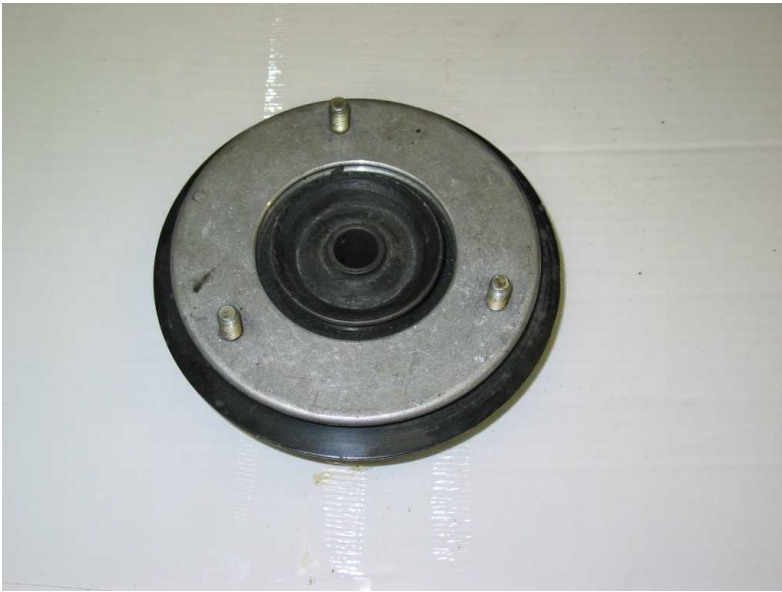
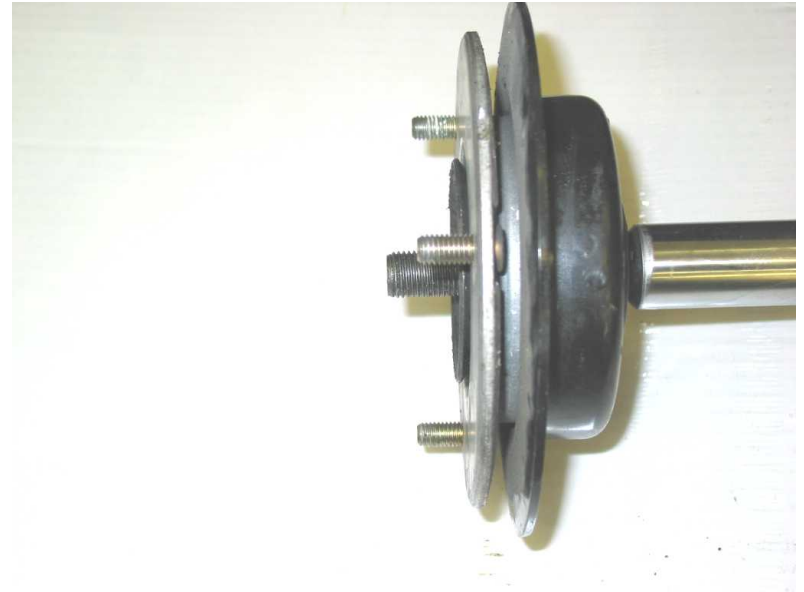
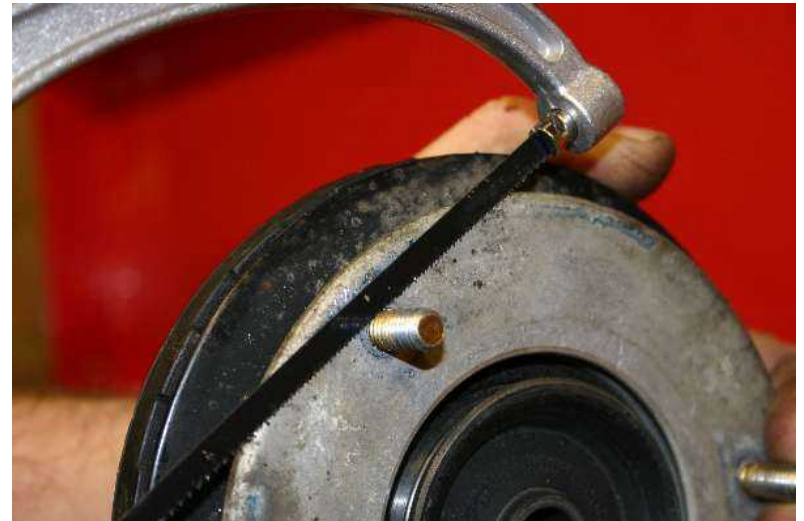
**Picture #1, #2, #3, #4**

**5. With a hacksaw or other cutting device, carefully cut the three 8mm bolts sticking up from the guide support. Make Sure that these bolts are cut as close as possible to surface of the hat plate.**

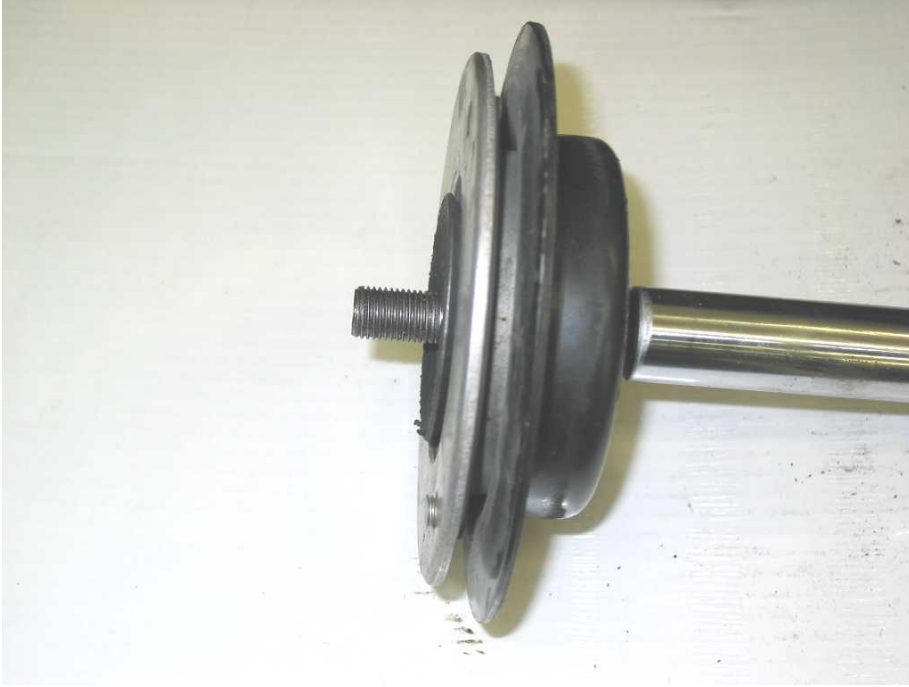
**Picture #5**

**6. With a file or other sanding/grinding device, file down the remainder of the bolts so they are flush with the top surface of the guide support. Notice the filed bolt at the top and the fresh cut bolt at the bottom? The bolt at the top will easily come out, the bolt at the bottom will not until it is filed or sanded down.**

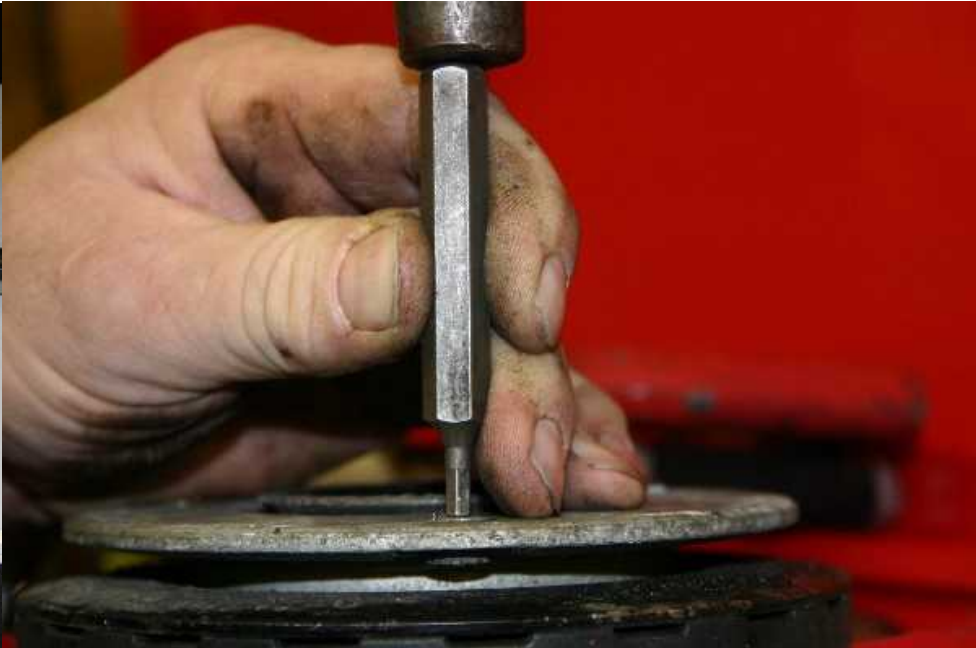
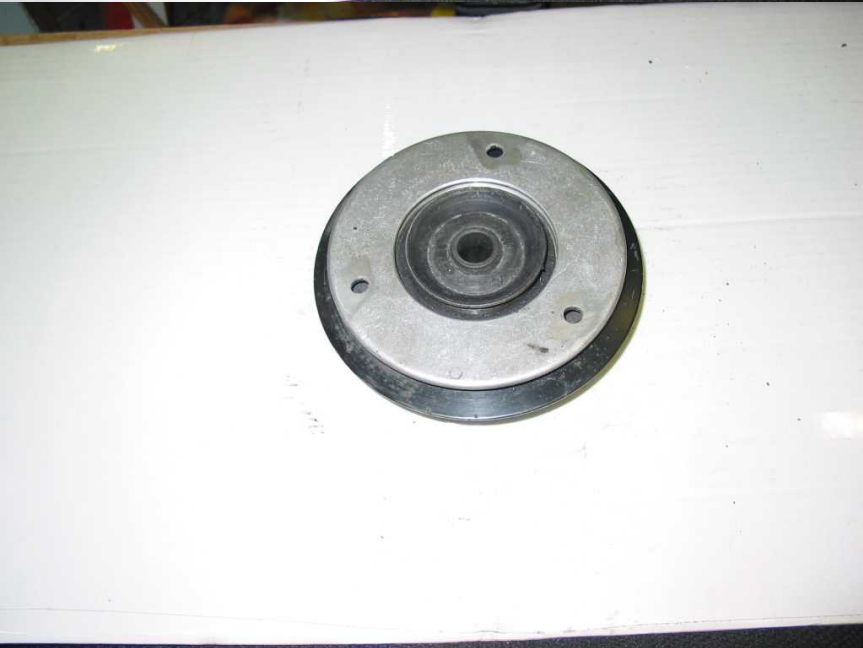
**Picture #6, #7, #8**

**7. With a small diameter punch, drive out the remainder of the bolts and remove from the assembly.**

**8. Clamp, block, or have someone hold the strut assembly in a vertical position.**

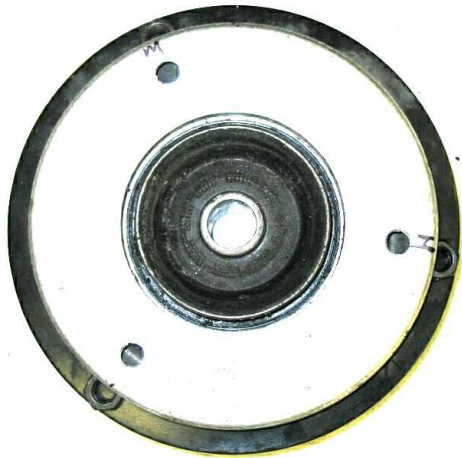
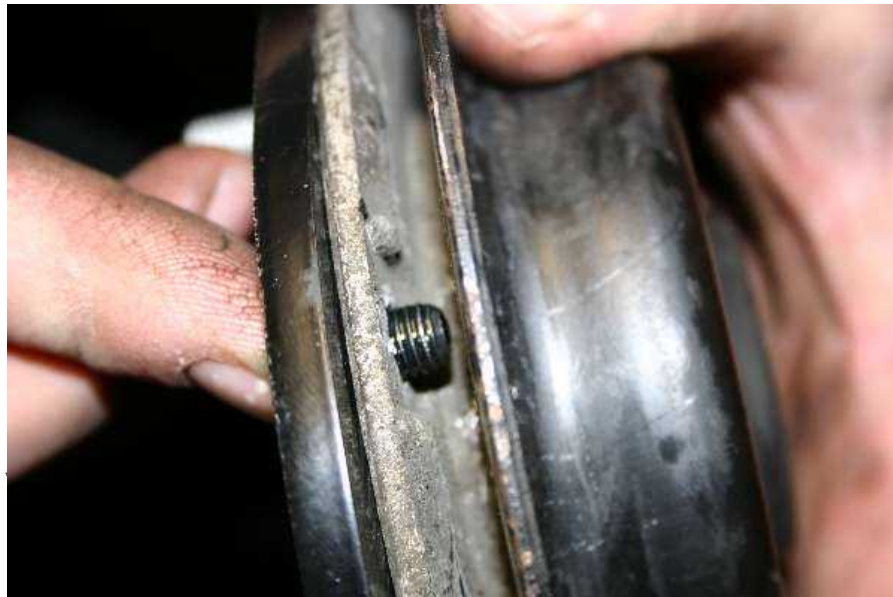
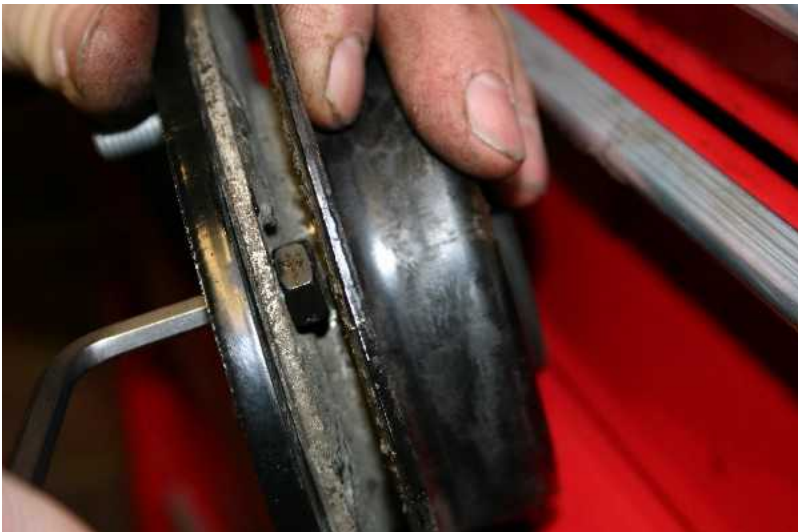
**Picture #9, #10, #11**

**9. Place three nuts around the ring using the spring perch as a shelf, carefully position the three nuts to line up with the holes where the bolts were driven out.**

**10. Apply red Loctite on a new (supplied) flat head bolt, using an allen wrench work thru the hole and catch the nut below, lightly tighten, repeat this for the remaining two bolts.**

**11. After all three bolts are installed, immediately tighten all to 36 Nm (27 lb/ft). It is important to tighten the nut rather than apply torque thru the allen wrench. The flat head bolt has too much head friction to reliably tighten correctly.**

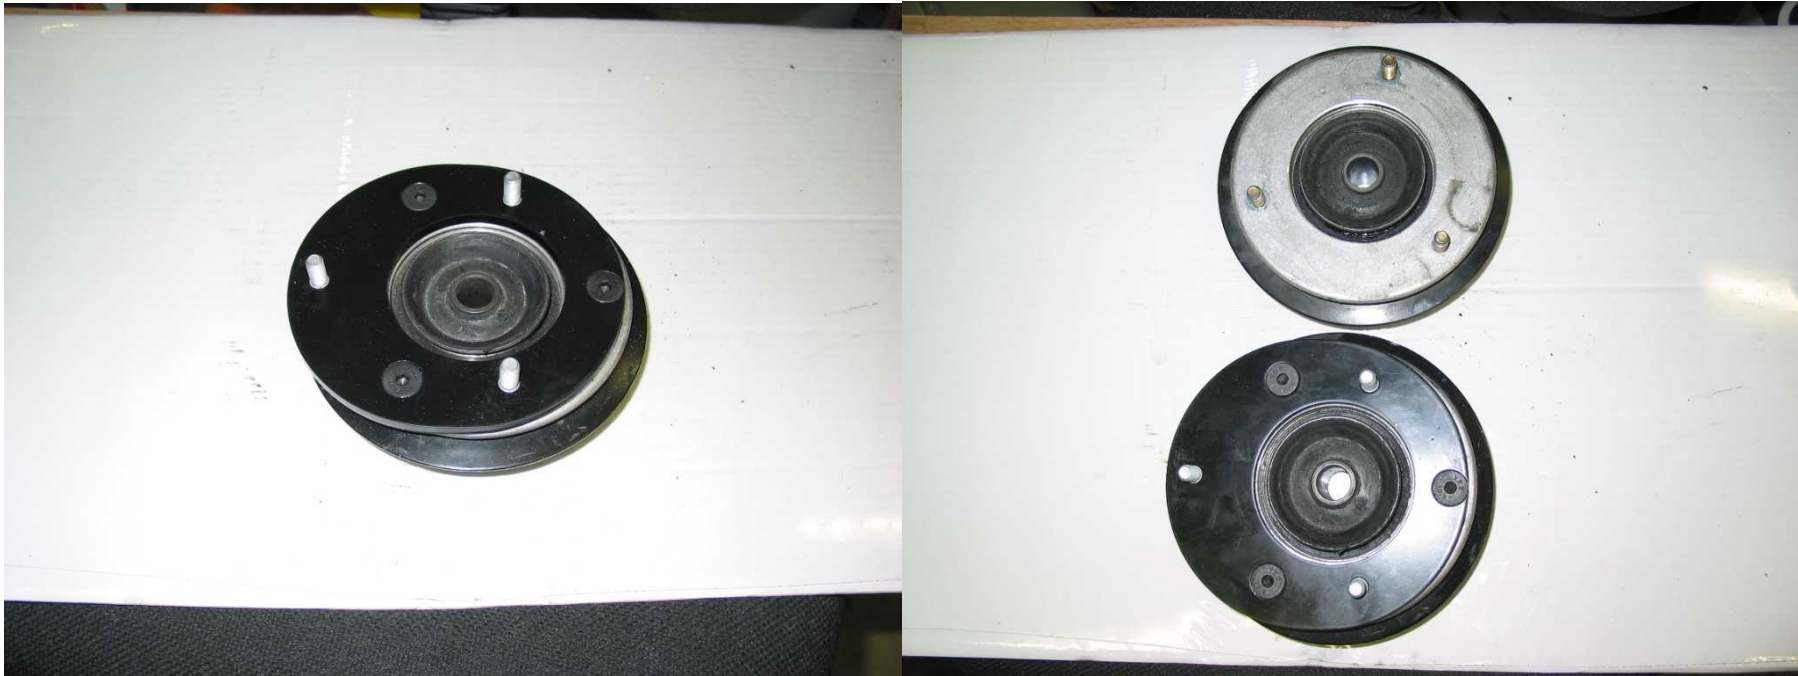
**Picture #12, #13**

**Finished assembly**

**Before and after comparison**

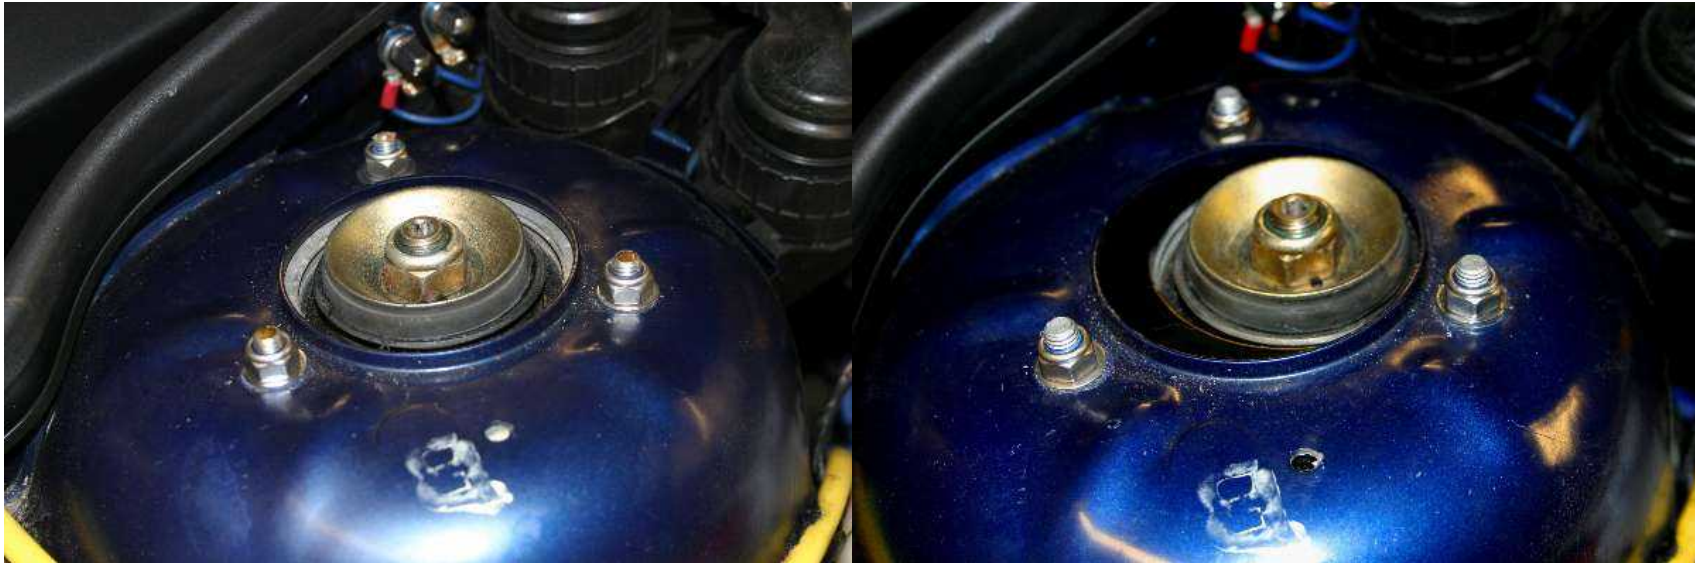
**Picture #14, #15, #16, #17**

**20. Final installation should look similar to this.**

**Before**

**After**

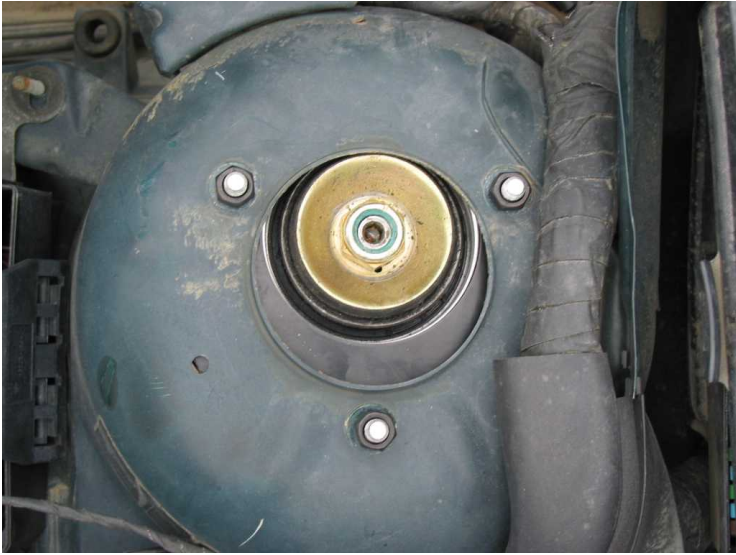
Stopper washer gets close to the edge of the hole on the top of the strut tower, the lower portion of the washer is rubber and will not cause any damage or noise. **DO NOT DELETE THIS WASHER**, it is necessary to keep the shock rod from pulling thru the elastomer bushing.

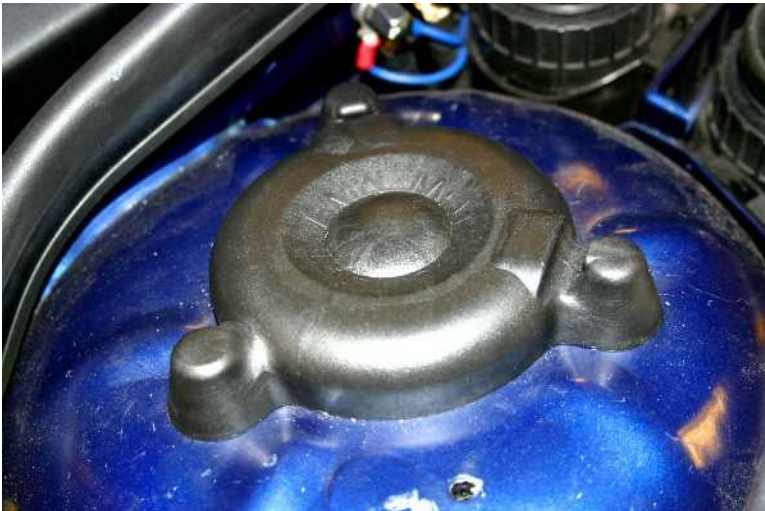
For a nice finished touch a cover may be purchased from BMW Part #31 31 2 227 387, \$12.60 ea retail. The original cover may not fit without modification because of the clearance issue between the stopper washer and strut tower as previously illustrated.

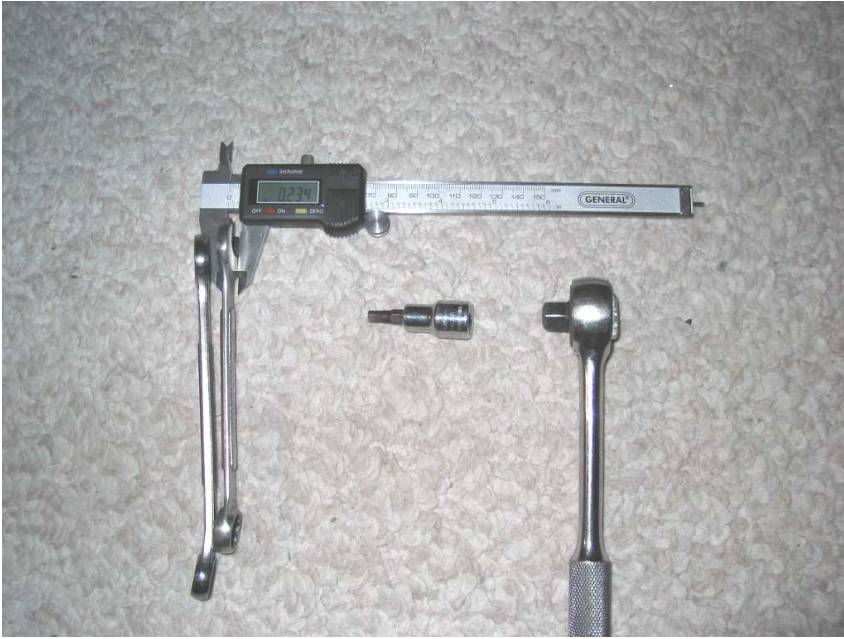
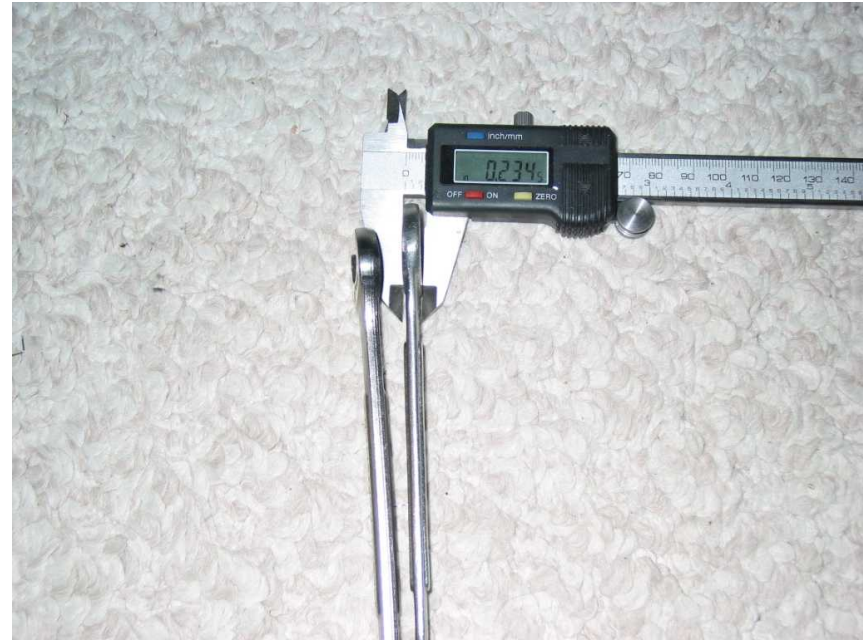
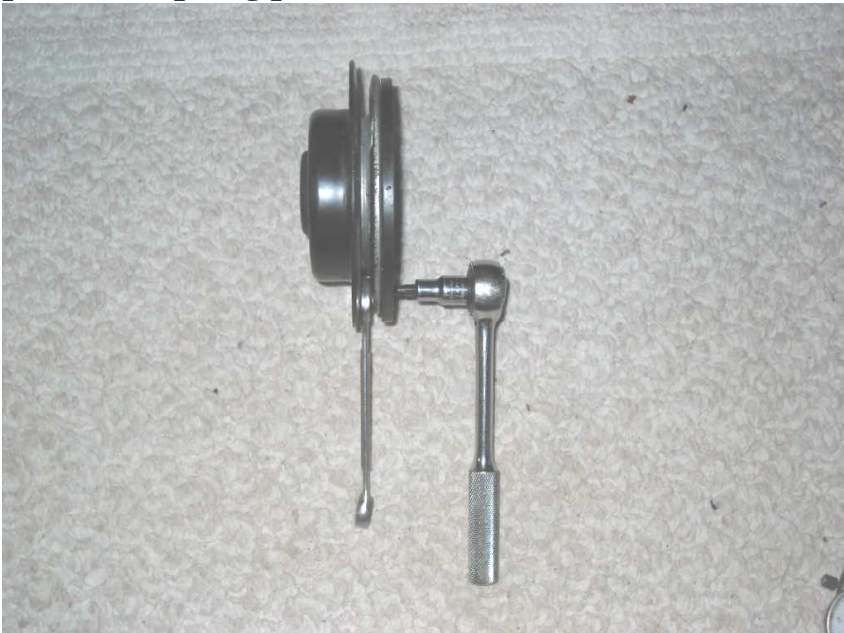
**Recommended tools:**

**Notice the 13 mm wrench in the caliper jaws is thinner, any thicker will not grip the nut well. Space between the top plate and spring perch is limited.**
